Re: November 2014 Monthly Progress Report
Administrative Settlement Agreement and Order on Consent for Removal Action
U.S. EPA Region 10 Docket No. CERCLA 10-2009-0255
Gasco Sediments Site within the Portland Harbor Superfund Site

Visual Observations Log Form

Monitoring Period: Monthly (Year 8)—November 2014

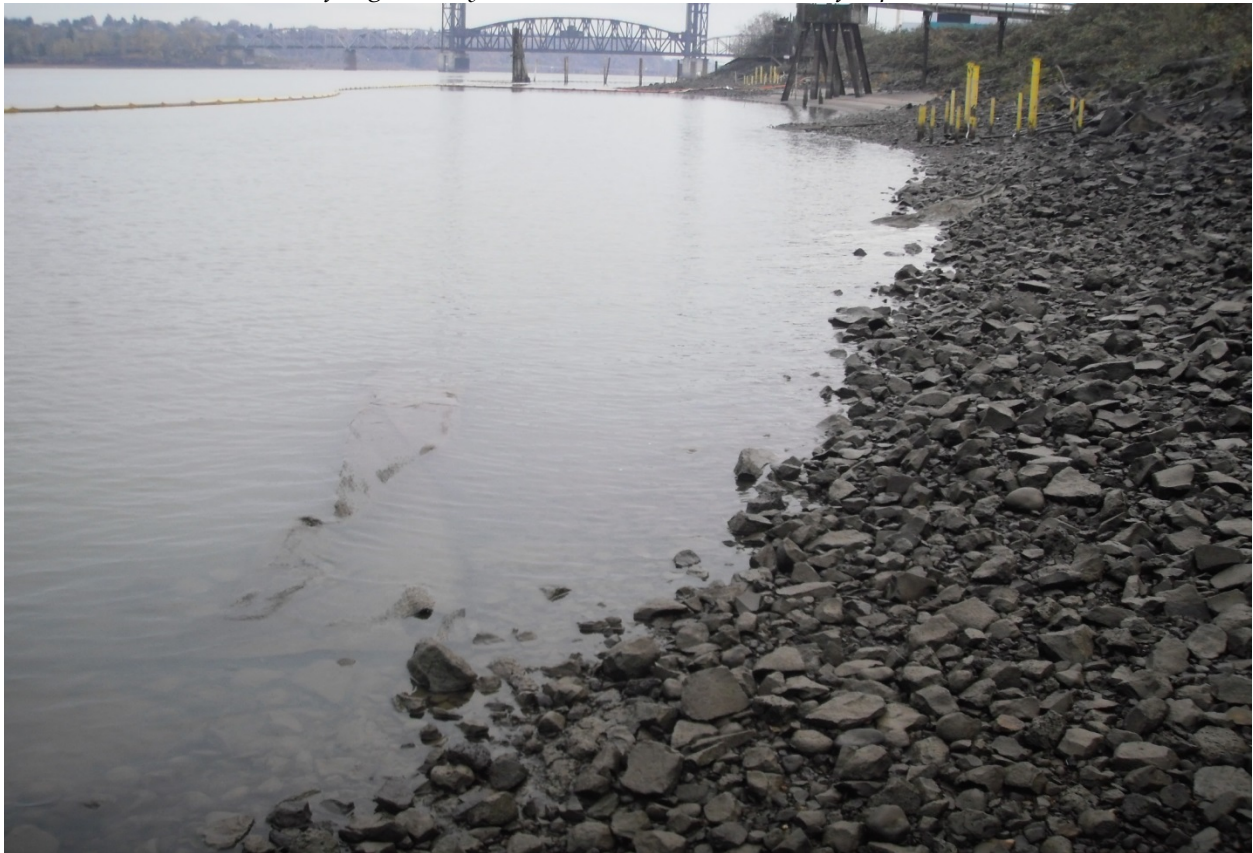
Photo 1 — *Visible section of organo-clay mat at the downriver extent of cap area (11/20/14):*

Observations of Erosion/Deposition: No additional erosion / deposition is evident along the shoreline. A section of organoclay mat material measuring 40 feet in length is partially submerged at the downriver extent of the cap at the water's edge (Photo 1). Two areas of exposed organoclay mat material measuring 1-2 feet in length up river of the 40-foot section identified above. A segment measuring 5-foot in length is approximately 8 feet shoreward of the water's edge near the lateral mid-point of the cap area. A 20-foot by 6-foot section of mat material is shoreward of the water's edge located perpendicular to the shoreline at the upriver boundary of the cap.

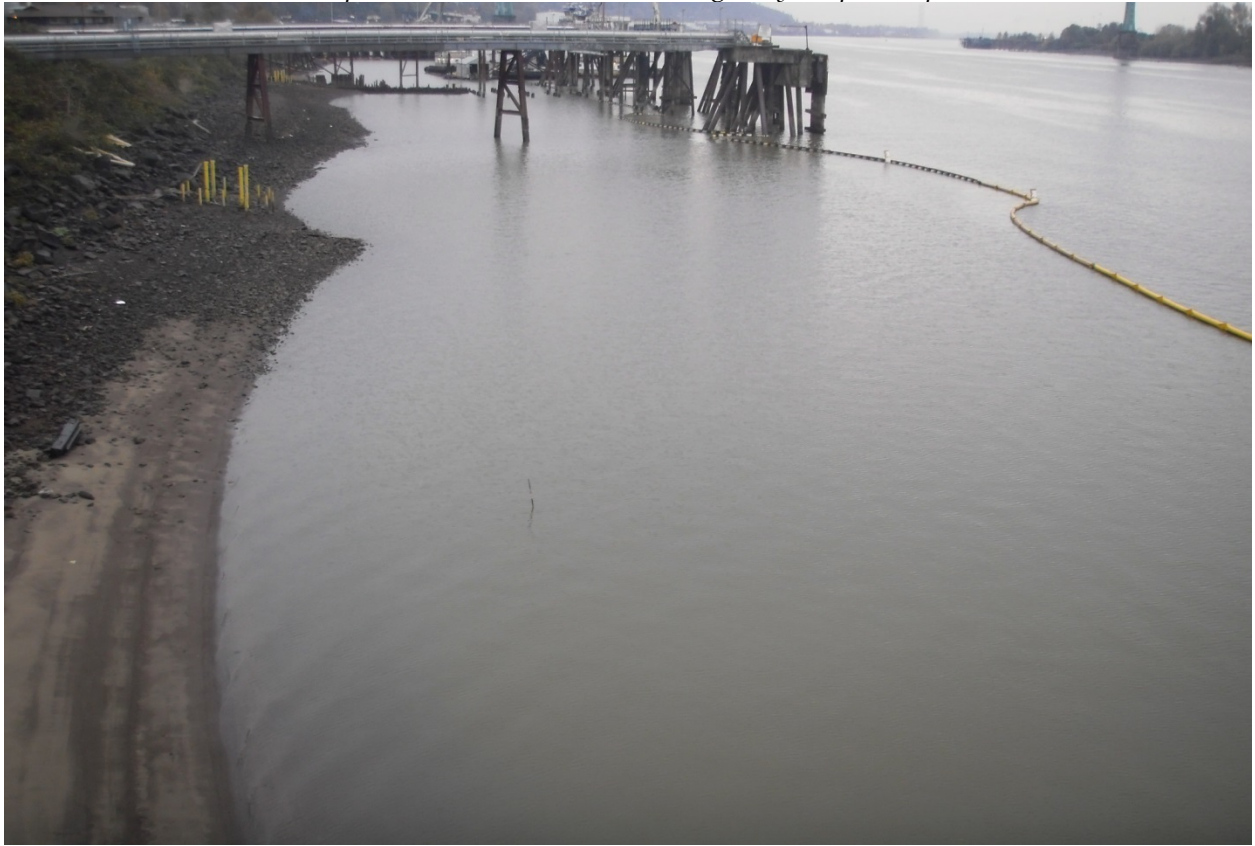
Photo 2— *FAMM oil boom placement and mariner warning buoys at pilot cap area. (11/20/14):*

Observations of Long-term Controls (i.e., oil booms, organo-clay mat, etc.) During the observation, the Fuel and Marine Marketing (FAMM) containment boom was placed across the cap area, between the upriver corner of the ship dock and the wooden dolphin (near the upriver extent of the site and near the Siltronic Corporation outfall). Buoys that identify the cap area to mariners are in place as installed. The position of the FAMM oil boom, warning buoys, and a general overview of the site shoreline is shown in Photo 2.

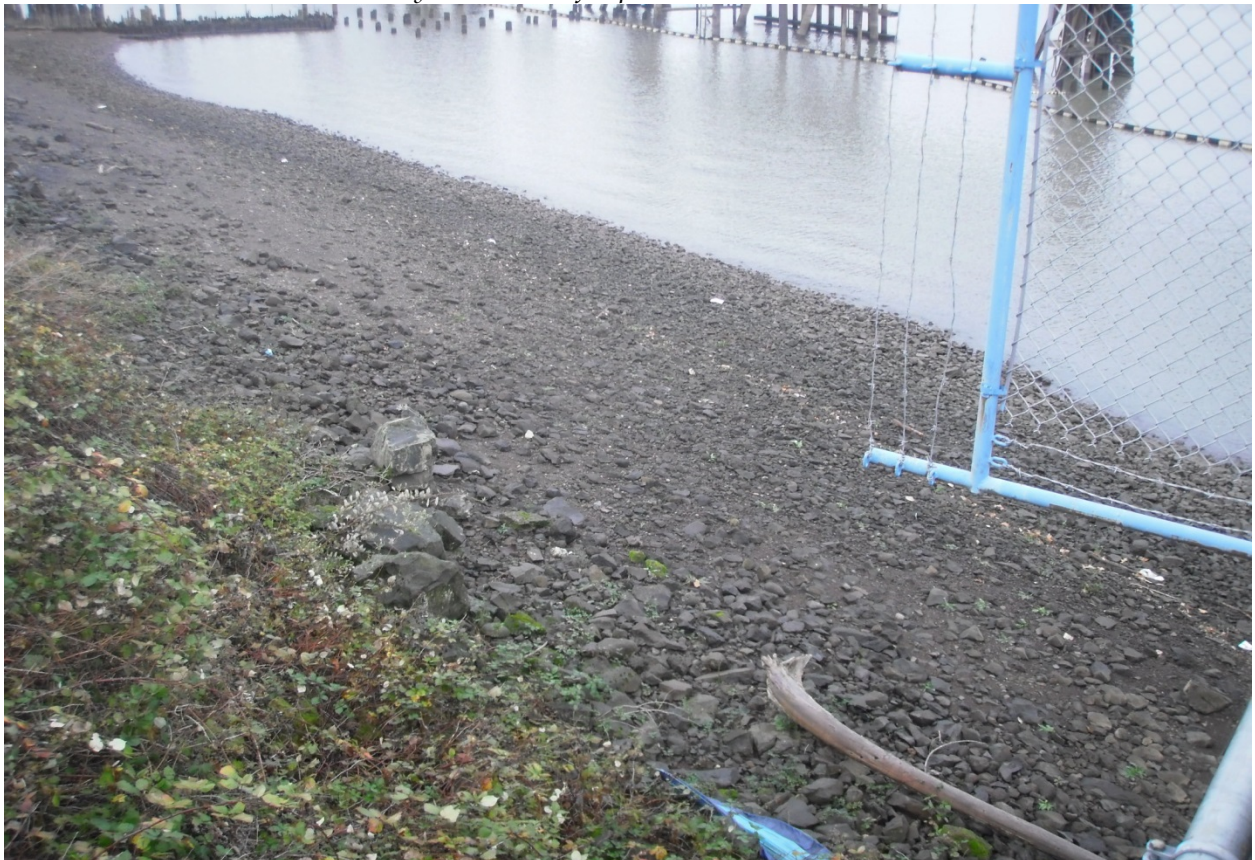
Photo 3 — *Conditions immediately downriver of cap area (11/20/14):*

No sheen is evident in or around the cap area. Photo 3 shows the water surface and shoreline immediately downriver of the sediment cap.
